REDUCING THE WASTEWATER - MANAGING THE PROBLEM.

Donald James Sorensen

East Coast (ECO) Wastewater Recycling Systems Ltd.
1 Sutton Ave, Clive, Hawkes Bay, New Zealand.

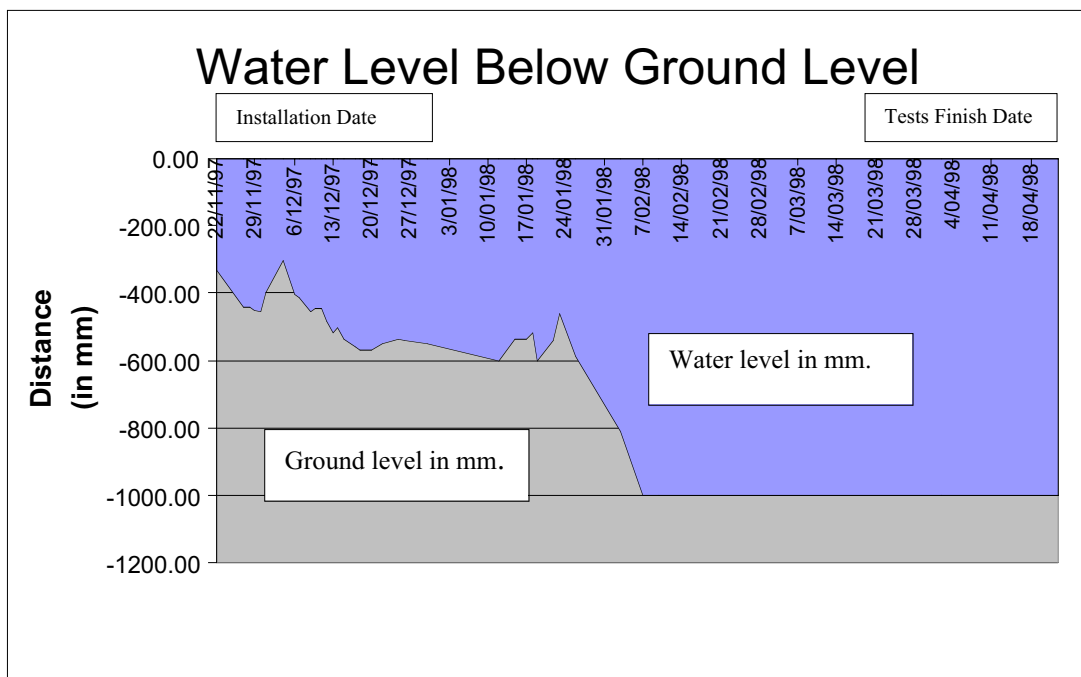
Figure 1 shows the reduction in ground water level from 330 mm below ground level on the 22nd November 1997, the day the system was installed. 1 metre or more on the 23rd April 1998 and the comments from the owners note book for that date were, "Dry sludge, appears to look more like silt. Septic tank outfall at correct level".

Figure 1. Reductions in groundwater levels after installation of ECO SYSTEM

All readings were recorded by the owner of 89 Rogers Road, Bay View and supplied to us for our documentation and reports. It should be noted that the maximum length below ground level that could be measured was one metre, as that was the length of the dipstick.

The graph shows the water level reduced to one metre below ground level between the 22-11-1997 and the 6-02-1998 and has remained at one metre or more since the testing finished on 8-04-1998.
